**White Point Landslide Status Report**

**RE: STATUS REPORT FOR 1/13/12 THROUGH 2/2/12  
WHITE POINT LANDSLIDE INVESTIGATION  
CITY OF LOS ANGELES W.O. E1907483, TOS 11-087  
SHANNON & WILSON PROJECT NO. 51-1-10052-012**

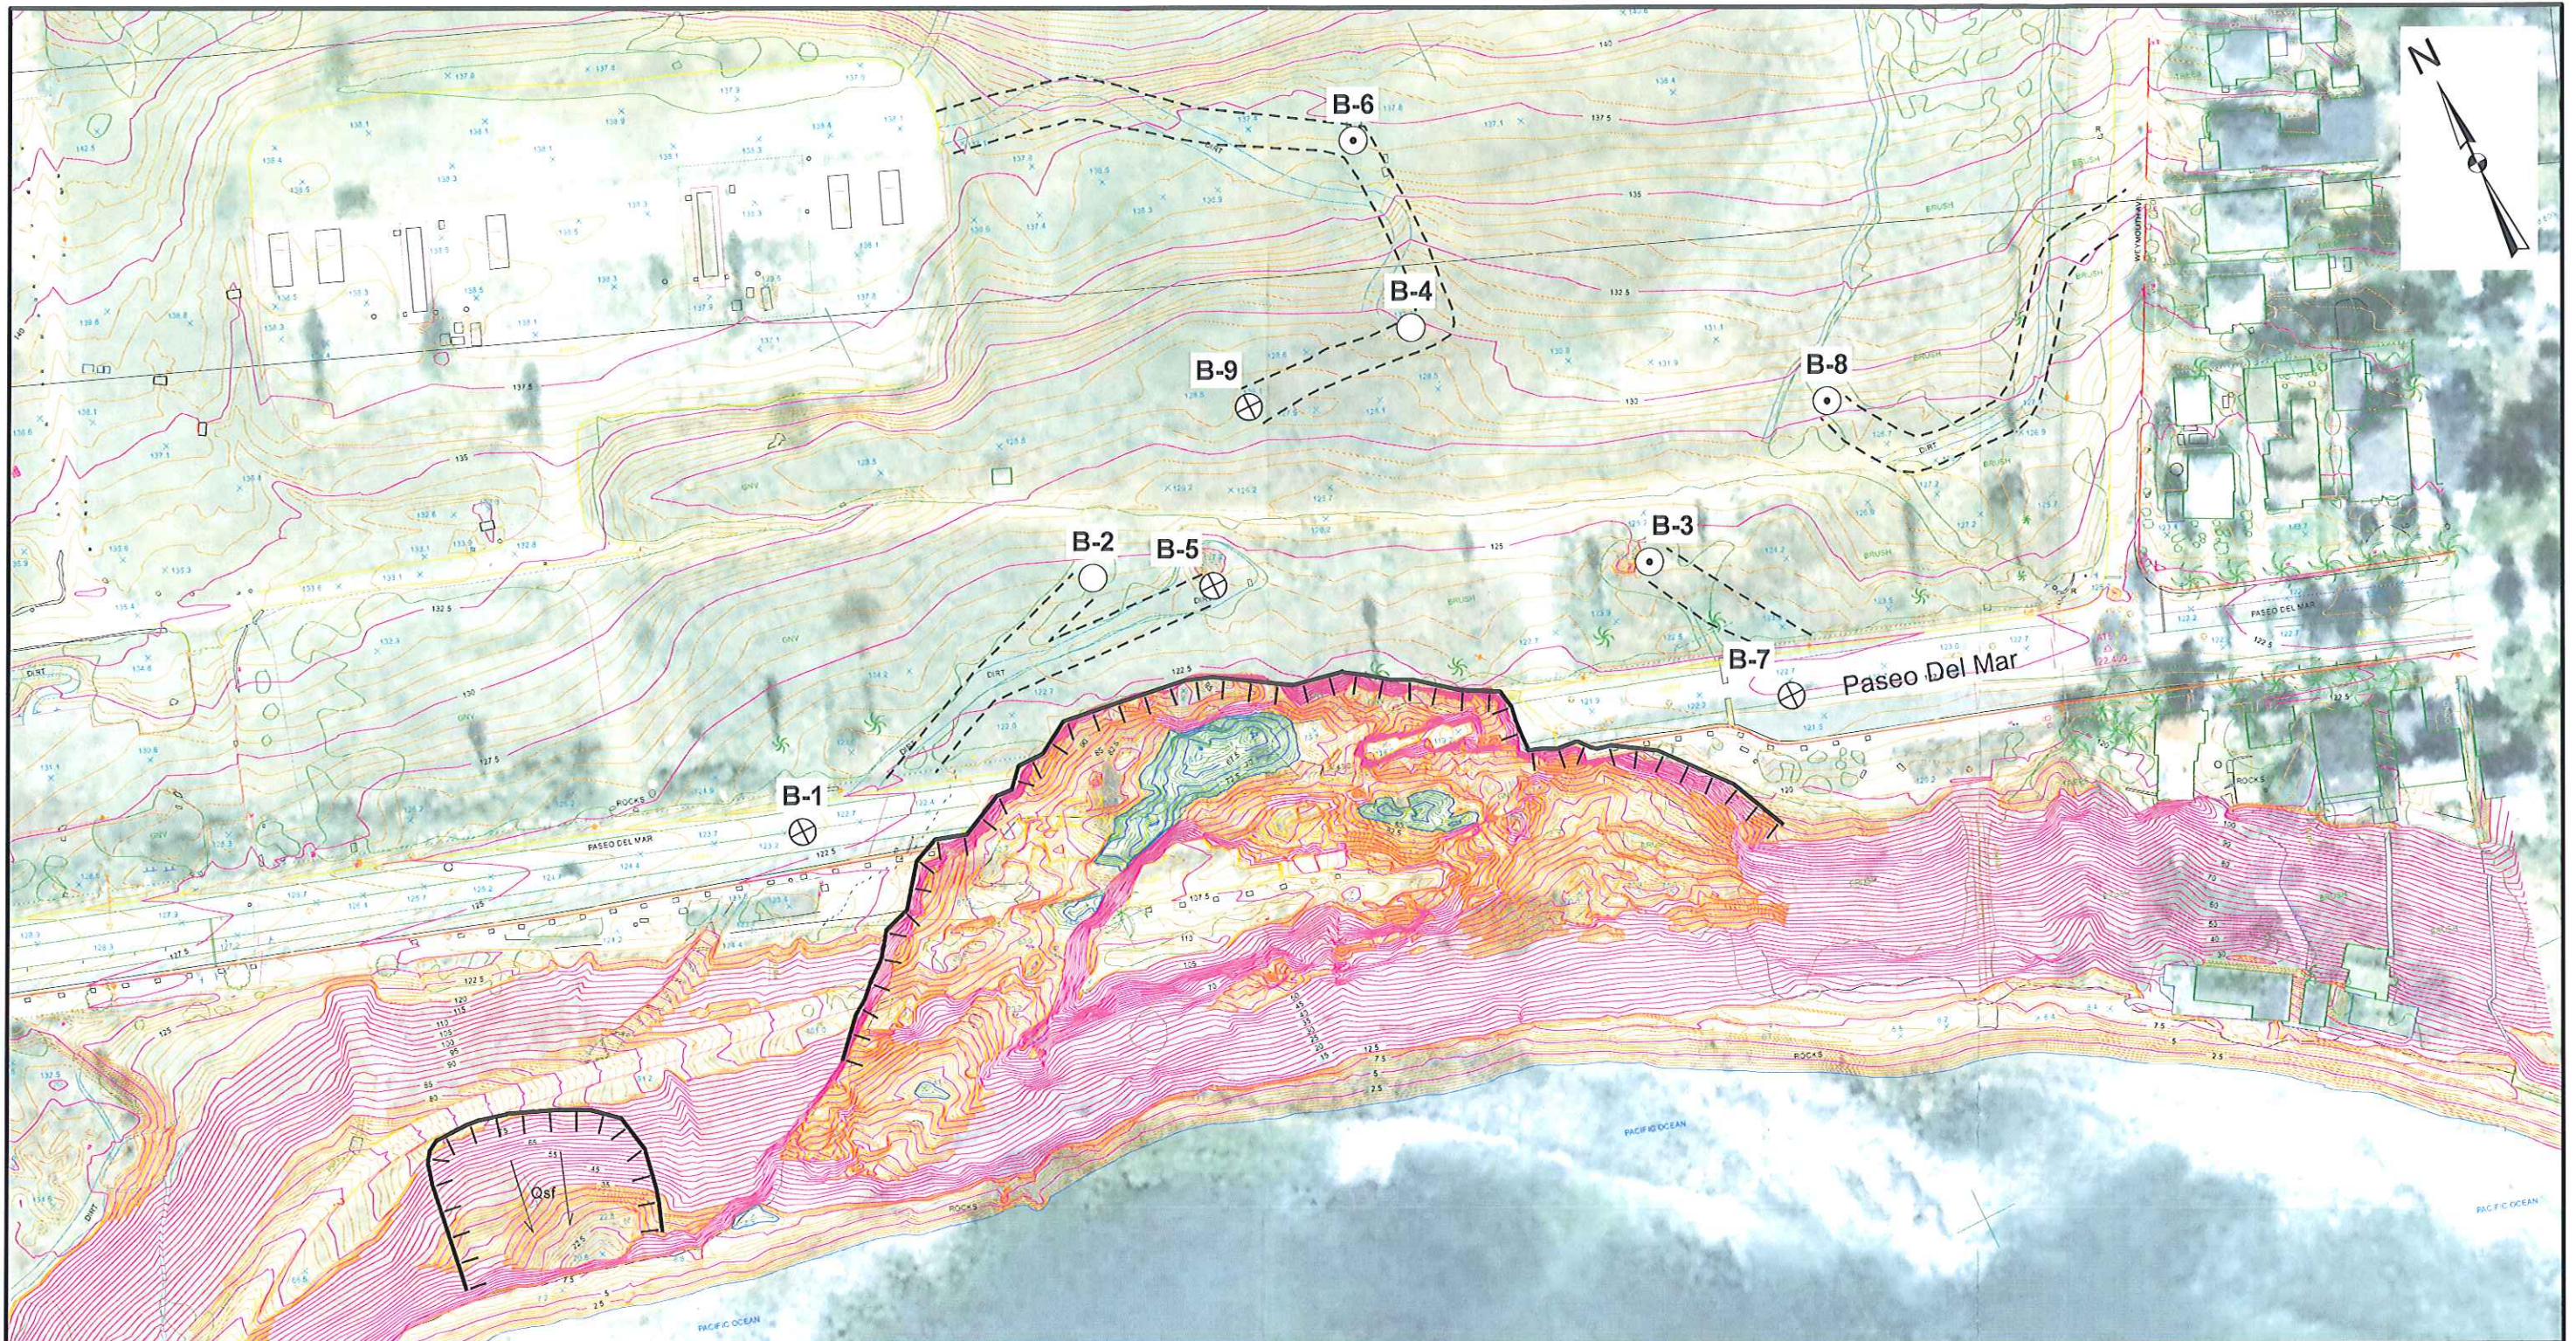
FIG. 1

**SITE AND EXPLORATION PLAN**
