APPENDIX G
INCLINOMETER READINGS

**TABLE G-1
WELL AND INCLINOMETER SUMMARY**

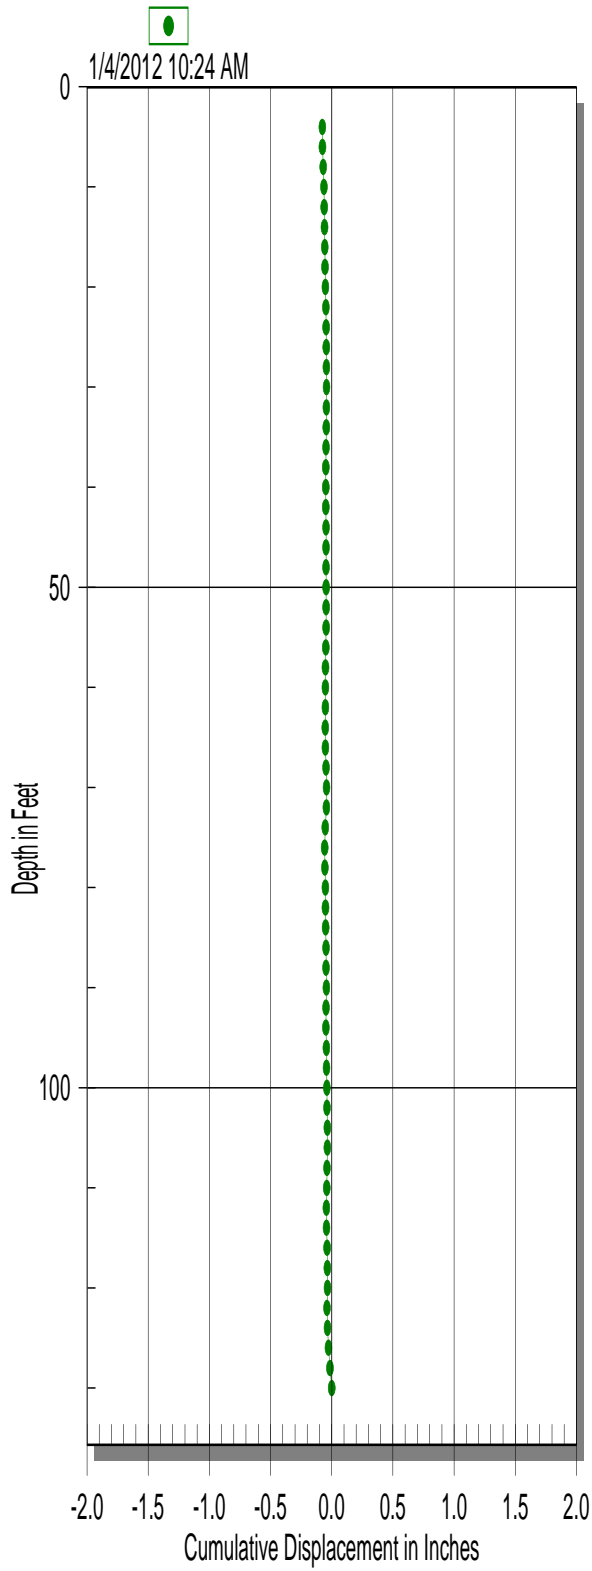
PASEO:B1 - A Axis

Initial survey: 12/6/2011 04:38 PM

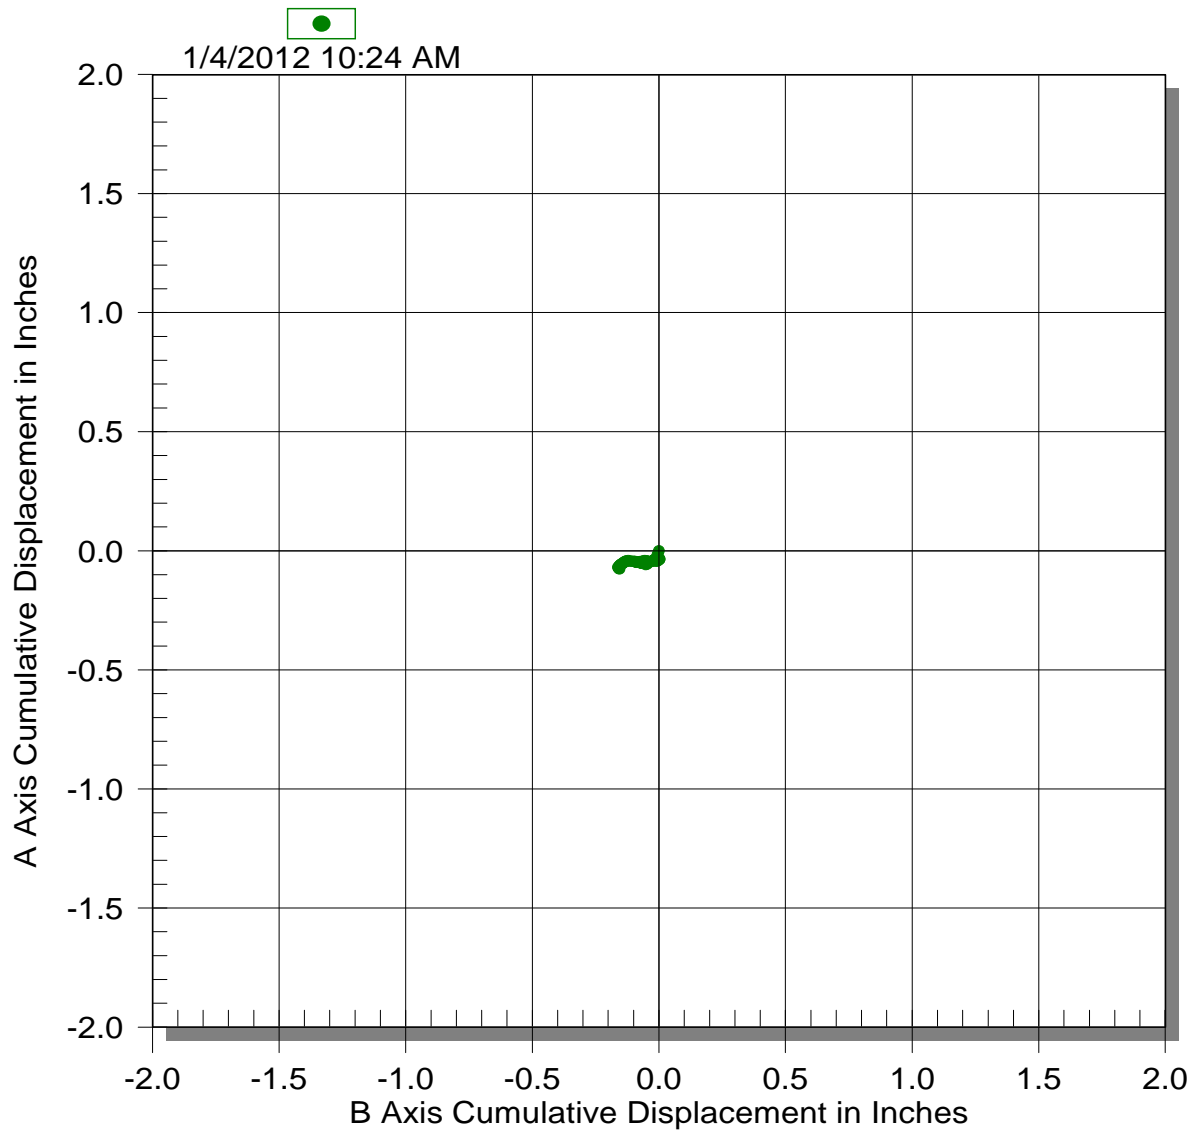
PASEO:B1 - A Axis vs B Axis

Initial survey: 12/6/2011 04:38 PM

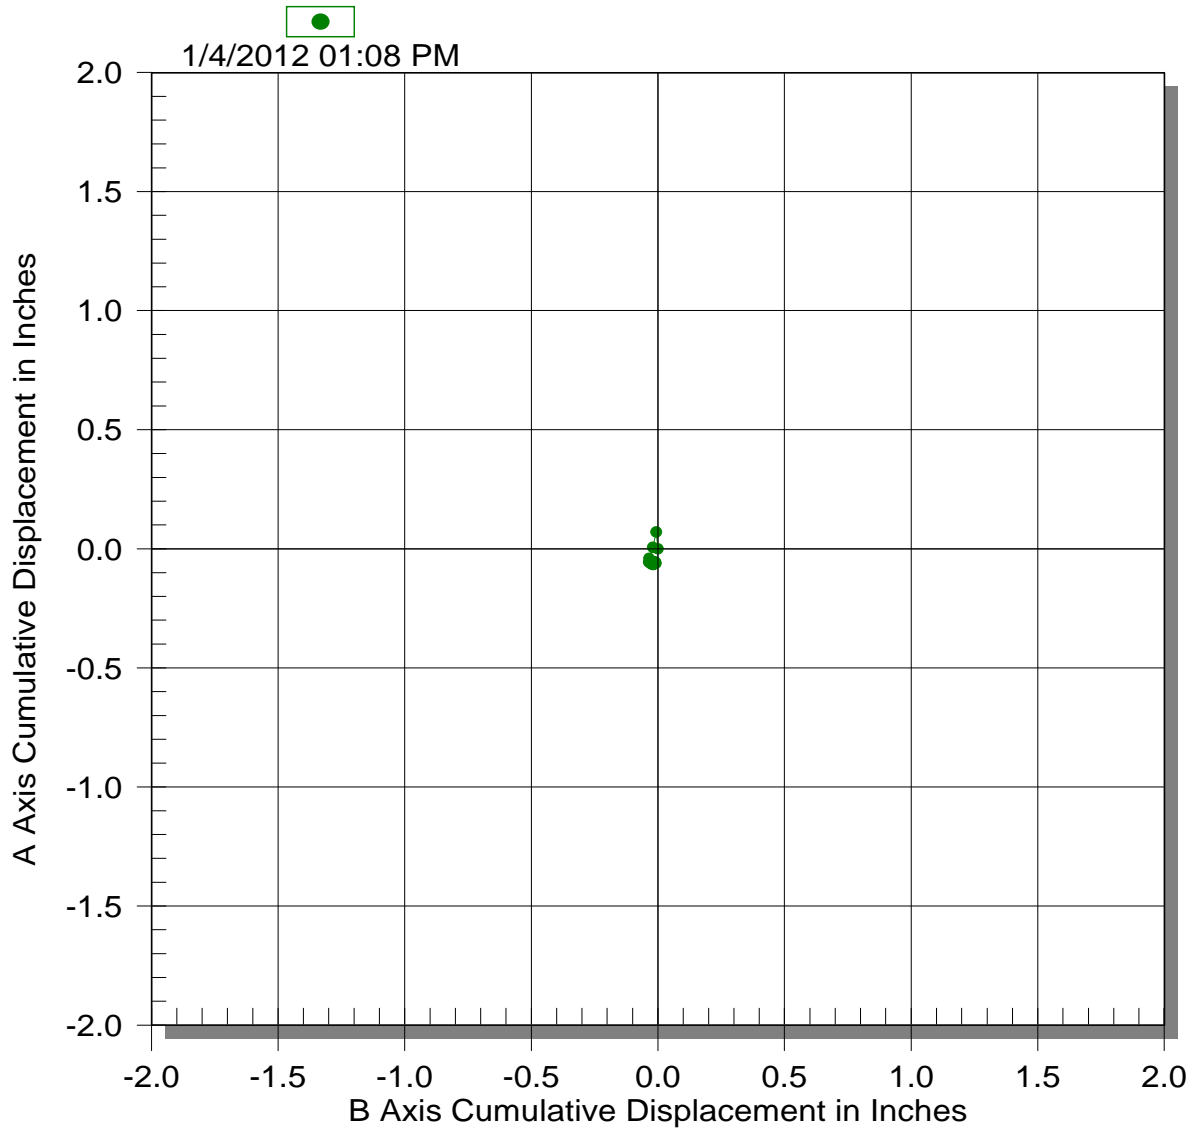
PASEO_:B9 - A Axis vs B Axis

Initial survey: 12/28/2011 02:19 PM
